Learning from Earthquakes

First Report on the Kashmir Earthquake of October 8, 2005

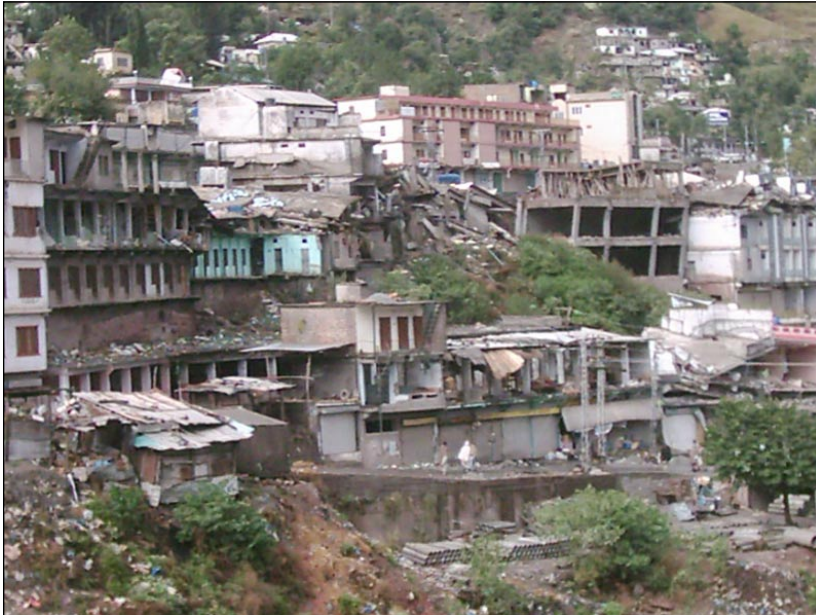
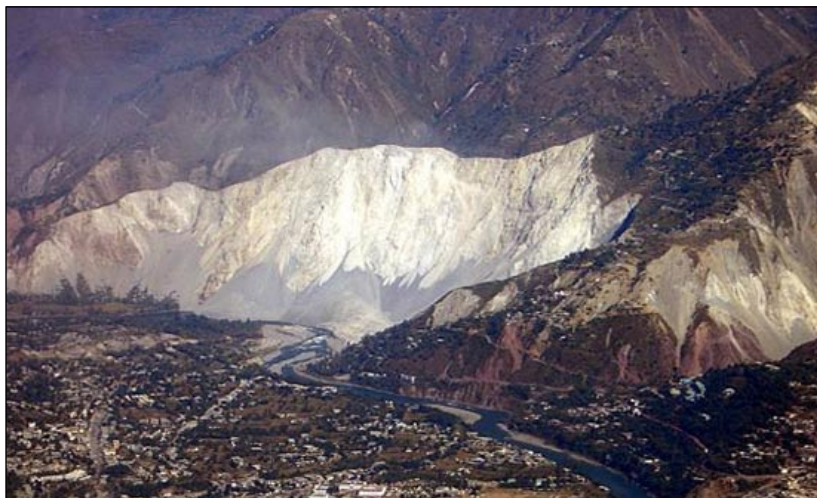
Figure 3: Large but surficial landslide just north of Muzaffarabad.
Note relatively minor amount of talus.

Landslides: There were numerous landslides, generally minor to moderate but massive in some instances, causing some deaths and injuries and blocking roads. A dramatic but surficial landslide occurred on the mountainside to the north of Muzaffarabad (Figure 3). It should be noted there was evidence of similar pre-earthquake slides in the same area.

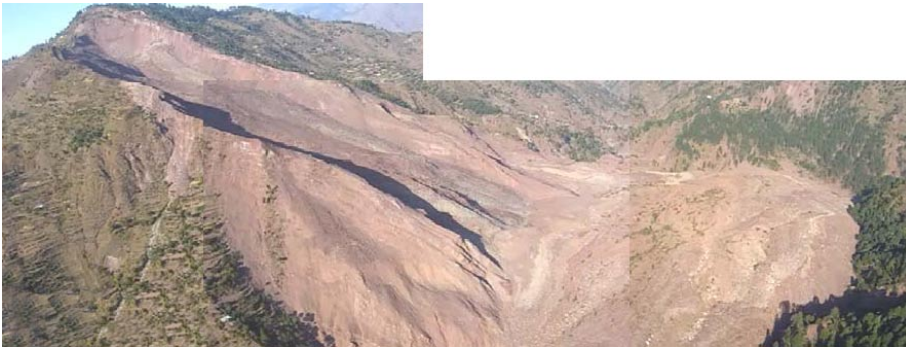
A massive landslide about 40 km SE of the epicenter appears to be a failure of an entire valley wall perhaps 5,000 feet high (Figure 4). Debris flowed down and across the valley, damming it with a crest approximately 2 km in length. The scale of this slide is analogous to the 1959 Hebgen Lake (Montana) slide. The slide warrants further investigation.

Figure 4. Large landslide about 40 km SE of Muzaffarabad. Head to toe is about 2.9 km (1.8 miles). Volume is estimated at 1-to 2 million cu. m.

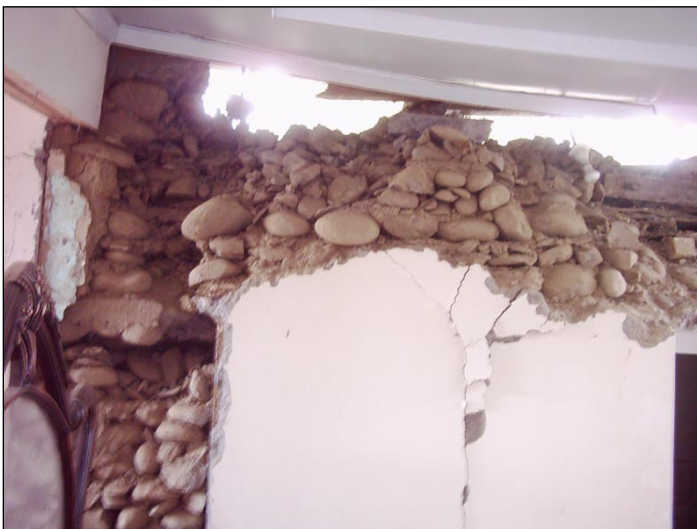
Buildings: A significant number of casualties and injuries in the rural areas were associated with the total collapse of single-story unreinforced earthen wall stone masonry buildings. The stone masonry walls consisted of irregularly placed undressed stones, mostly rounded, that were laid in cement sand, mud mortar, or even dry in some cases (Figures 5a and 5b). A number of features seem to be responsible for widespread collapse of buildings.

Figure 5a. Failure of unreinforced stone masonry walls in Muzaffarabad.

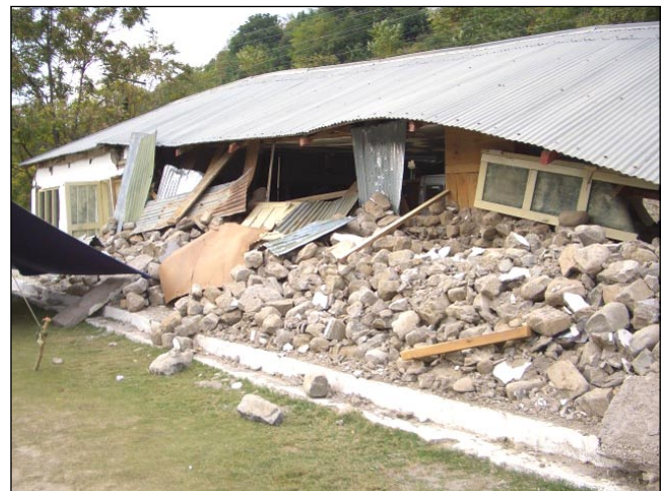
Figure 5b. Collapsed stone masonry building (metal roof)

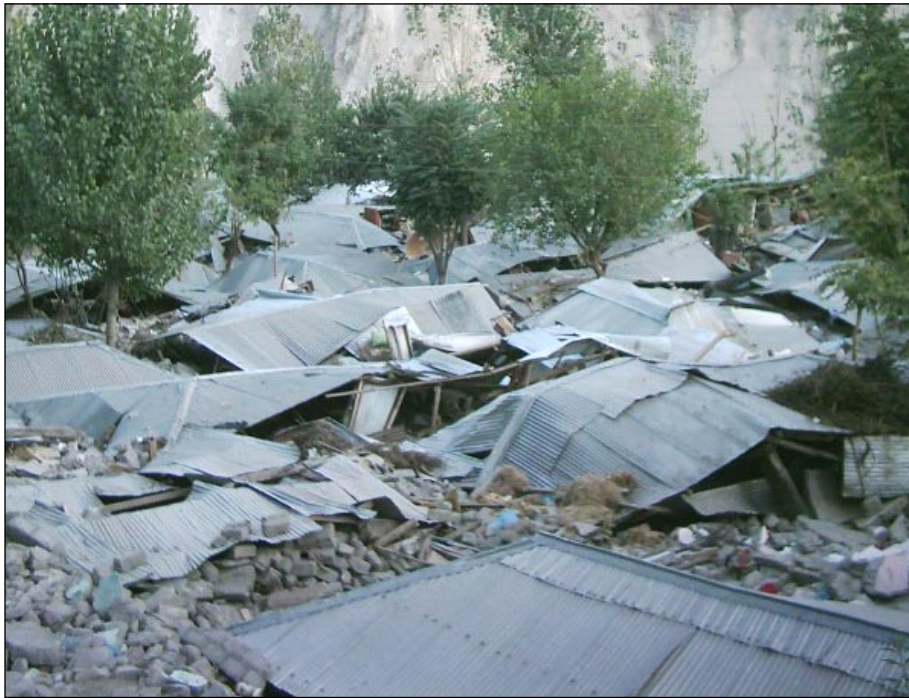
Concrete block masonry buildings are widely used in the cities and less so in the villages. Solid concrete blocks 6" thick, 6" wide, and 12" long are laid in cement sand mortar. The collapse of block masonry buildings was responsible for a major portion of deaths and injuries in cities (see Figure 6). The most probable reasons for the failures were (1) poor quality of concrete used for fabrication of blocks, which rendered low strength blocks; (2) poor quality of mortar; (3) inadequate thickness of walls—the main shear-resisting elements; (4) no integrity of the wall in the transverse direction; and (5) weak connections at corners.

Figure 6. Collapse of unreinforced concrete block masonry houses in Kamsar near Muzaffarabad (Latitude N34° 24.6' and Longitude E73° 28.5').

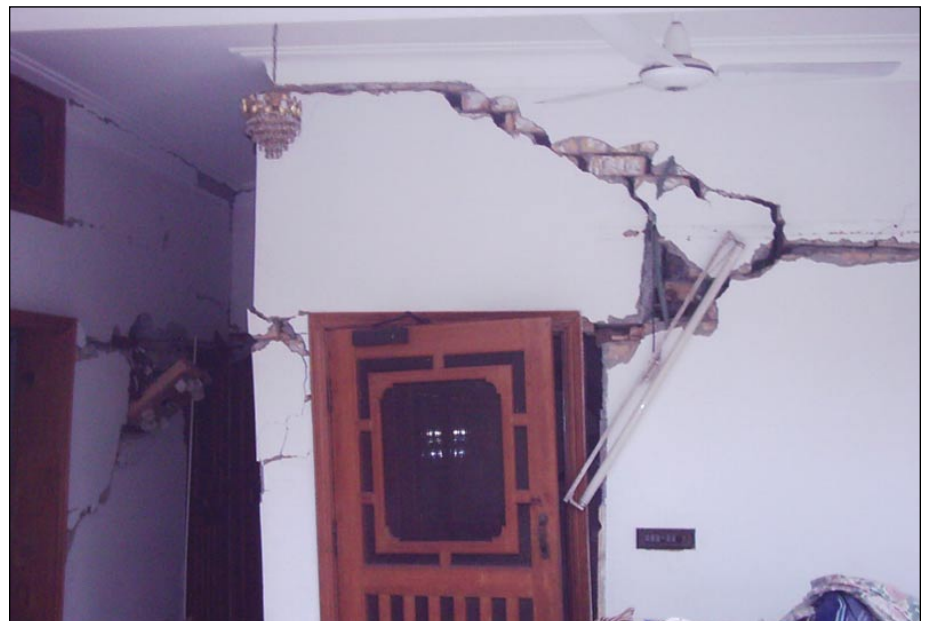
By and large, brick masonry buildings are the most common form of masonry in towns, and performed better than the stone or concrete block masonry buildings. According to the Earthquake Engineering Center at NWFP UET Peshawar, unreinforced one- and two-story brick masonry buildings, with RC slabs as roofing, comprise 25% of the total building stock of the cities near the epicenter. About 30% of these buildings collapsed, while the rest suffered slight damage. Because the unit cost of brick masonry is higher than that of other forms of masonry, the owners are people with financial resources. Along with better workmanship, good quality mortar is used in the construction of brick masonry buildings. However, no evidence of either bond beams or other earthquake-resistant improvement techniques was found in such buildings (Figure 7).

Figure 7. Severely damaged unreinforced brick masonry wall in Muzaffarabad.

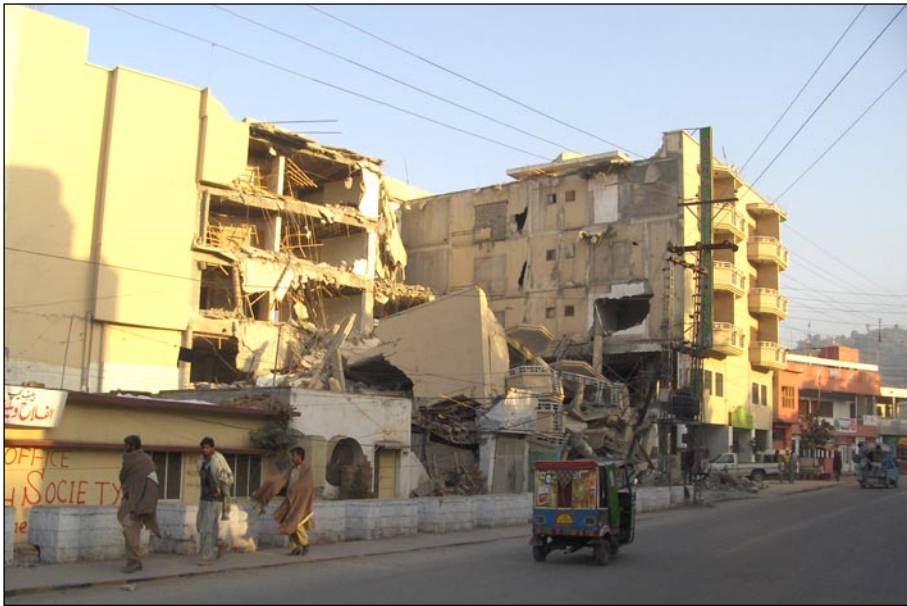
buildings collapsed and more were seriously damaged (Figure 8). In severely damaged buildings, columns were observed to have cracked at the beam-column intersection. Figure 9 shows the formation of a plastic hinge in one of the columns of a building. Inclined cracks were also found at the mid-height of some columns. Beams were found to be intact and undamaged, but infilled 4½" masonry walls were extensively damaged.

The failures of reinforced concrete frame structures may be attributed to deficient design for seismic forces, improper length and location of column splices, improper spacing and anchorage of lateral ties in columns, and poor quality of concrete.

Figure 8. Collapse of Sangam Hotel, an 5 storeyed RC framed building in Domel, Muzaffarabad (Latitude N34° 21.3' Longitude E73° 28.3').

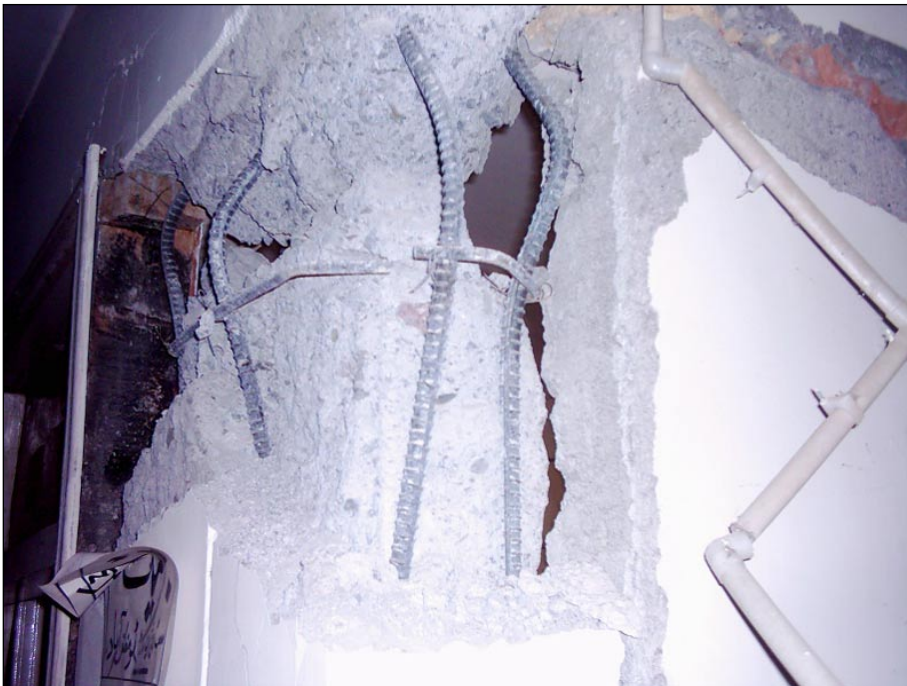
Figure 9. Formation of plastic hinge in the column near the beam-column joint in a hospital building in Mansehra.

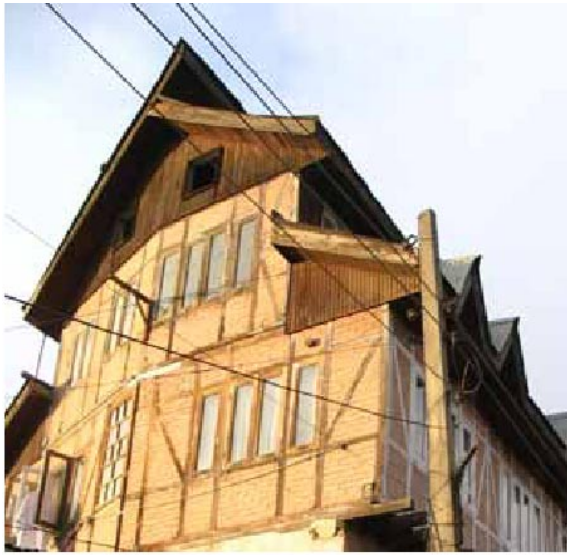
wall, even when the walls in bottom stories are made of brick or stone masonry (Figure 10a).

Figure 10. Traditional masonry for proven earthquake resistance: (a) Dhajji-dewari system of timber-laced masonry for confining masonry in small panels; (b) Taq system of embedding timber logs in thick walls; and (c) brick masonry piers for timbers in stone infilled wall.

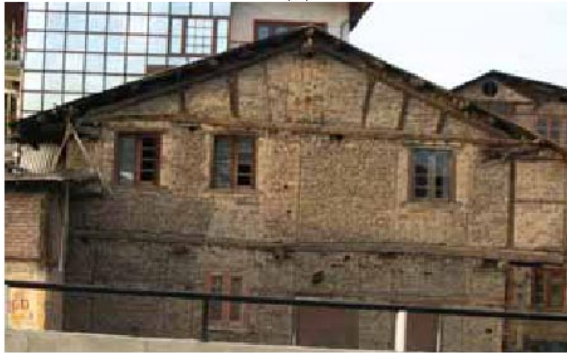
(b)

In older construction, another form of timber-laced masonry, known as *Taq* has been practiced. Large pieces of wood are used as horizontal runners embedded in the heavy masonry walls, adding to the lateral load-resisting ability of the structure (Figure 10b). The concept of Dhajji-dewari has also been extended to a type of mixed construction in which stones are used as filler hard material in wall panels that are created by a series of piers in softer coursed brick masonry, which has greater integrity under lateral loads (Figure 10c).

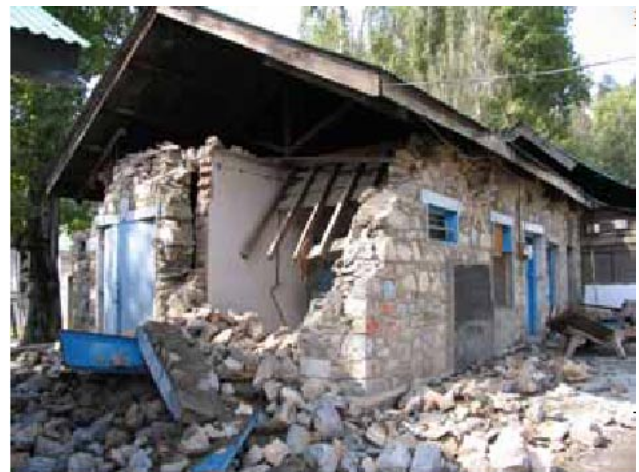
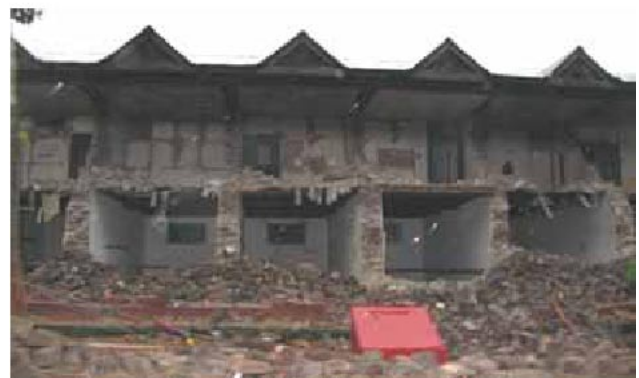
Figure 11. Out-of-plane collapse of stone masonry walls.

Undressed stones are laid in mud or cement mortar and plastered in cement mortar to provide a finished surface. Most government buildings—hospitals, schools, jails—built during the last four or five decades suffered heavy damage, especially when the structure was old. Such out-of-plane failures arising from the dynamic instability of unsupported walls were evident in the collapse of tall slender end walls in brick masonry as well. Moreover, masonry walls are weakened by openings for doors and windows (Figure 11).

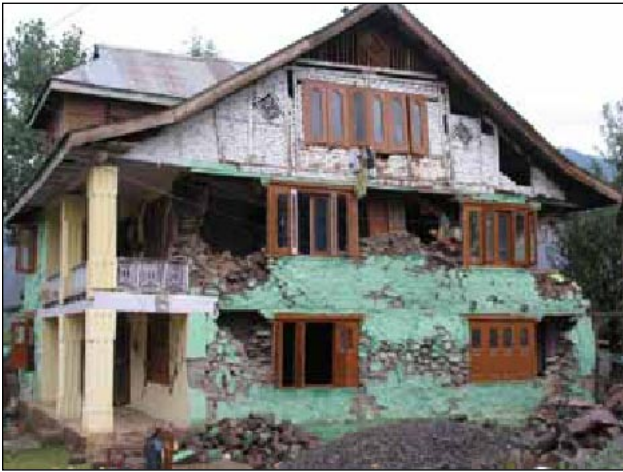
Figure 12. *Timber-laced masonry in gable wall suffered little damage, whereas extensive damage in stone masonry wall rendered the building unsafe at Uri.*

However, timber-laced masonry can maintain its integrity even when the supporting masonry walls in lower stories are severely damaged (Figure 12). There are many small scale buildings using all timber construction which have generally performed satisfactorily. Even large buildings in timber had no observed damage whereas

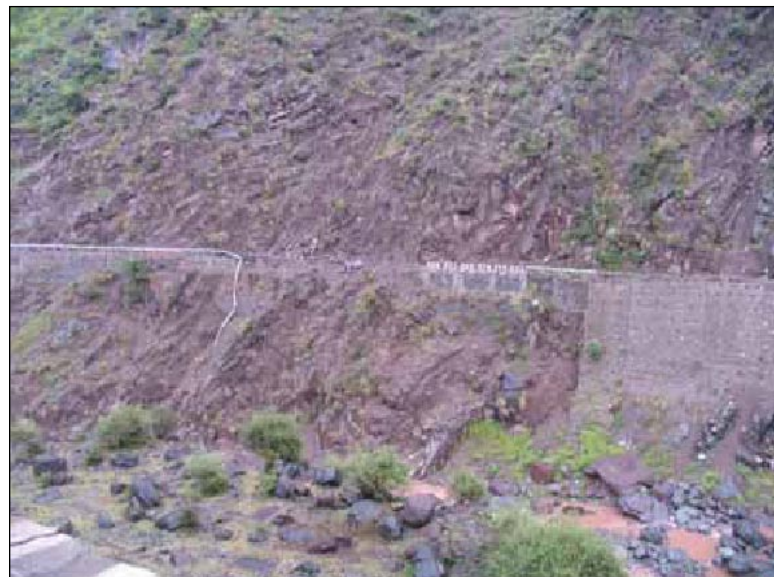
Figure 13. *Landslide on NH1A near Uri disrupted the road traffic.*

Roads closer to the epicentral area in the mountainous region suffered extensive landslides which resulted in the closure of traffic for many days (Figure 13). The road to Tangadhar from Kupwara was not open even a week after the quake. Fissures on roads were noticed at places that were primarily due to ground movement across unstable slopes.
